Image Gallery

Clinical signs of chronic venous disease

Venous anatomy and duplex ultrasound scanning

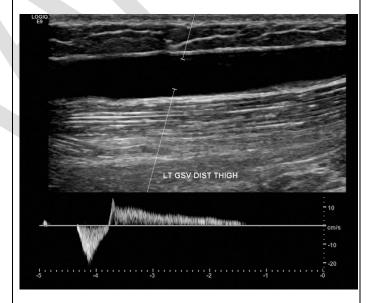
Image 24: Incompetent GSV
Colour and spectral Doppler imaging of the GSV with provocation manoeuvre. The sampled GSV segment demonstrates venous reflux upon the release of augmentation manoeuvre or diastolic phase following muscular contraction.

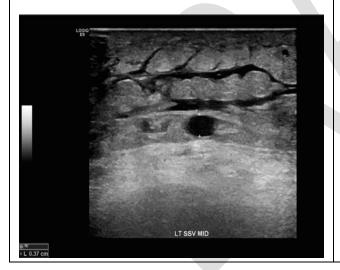
Image 87: Lymphodema.

Ultrasound image of a patient with lymphedema shows thickened subcutaneous tissue with increased echogenicity, accompanied by multiple hypoechoic areas representing fluid accumulation, characteristic of lymphedema.
